Manhole Inspection Summary

Manhole # S25I__027MH

Insp Date: **9/6/07 9:37 AM**

Location Address: **42 CARROLLTON AVE**

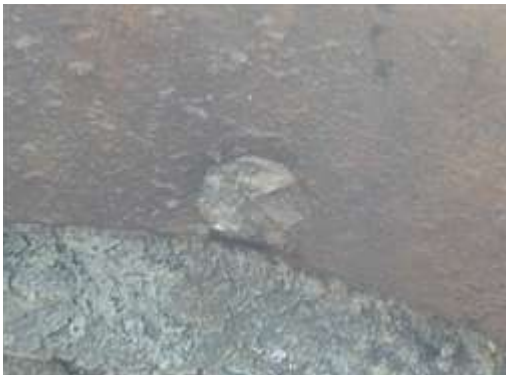
Defect 4

Condition: ☐ Sound ☒ **Cracked** ☐ Leaks

HOLE IN FRAME

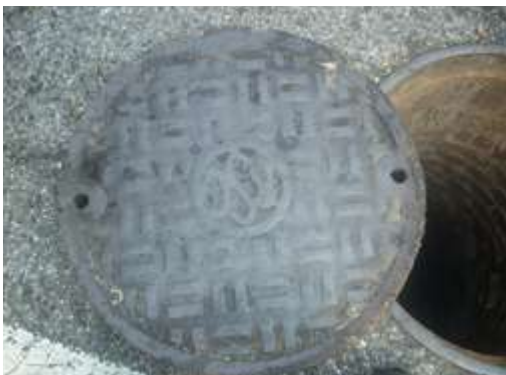
Defect 2

Condition: **Worn**

WORN COVER

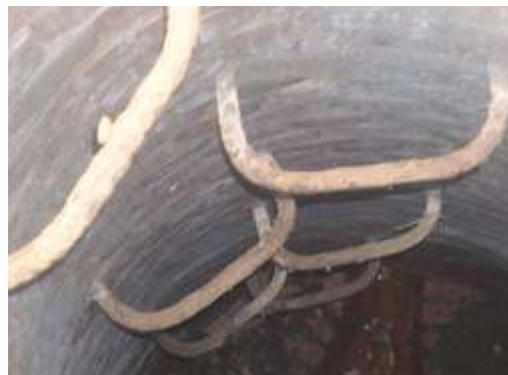
Defect 1

Count: **6** Missing: **0** ☒ **Corroded**

CORRODED STEPS

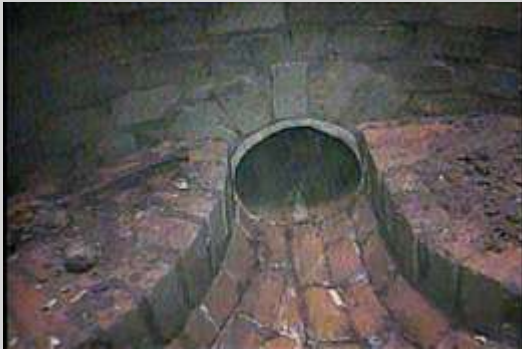
12 O'Clock Outflow

Pipe Height: **7.2** (in.) Rod and Bar (Angled)
Pipe Material: **Clay** ☐ Pipe Lined
Invert Depth: **11.19** (ft.) Flow Characteristics: **Slow**
Deposits: ☒ None ☐ Mud ☐ Sludge ☐ Debris ☐ Grease
Silt Depth: (in.) Deposits Extent:
Infiltration: **None** Pipe Seal Cond: **Sound**

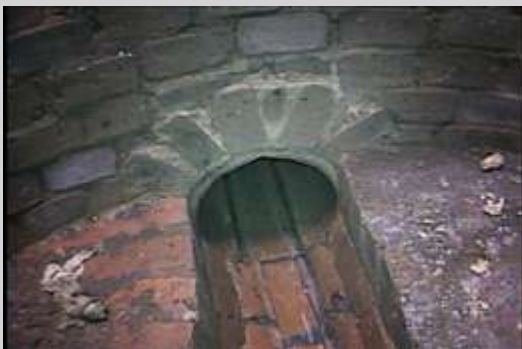
3 O'Clock Inflow

Pipe Height: **8.4** (in.) Rod and Bar (Angled)
Pipe Material: **Clay** ☐ Pipe Lined
Invert Depth: **10.76** (ft.) Flow Characteristics: **Slow**
Deposits: ☒ None ☐ Mud ☐ Sludge ☐ Debris ☐ Grease
Silt Depth: (in.) Deposits Extent:
Infiltration: **None** Pipe Seal Cond: **Sound**

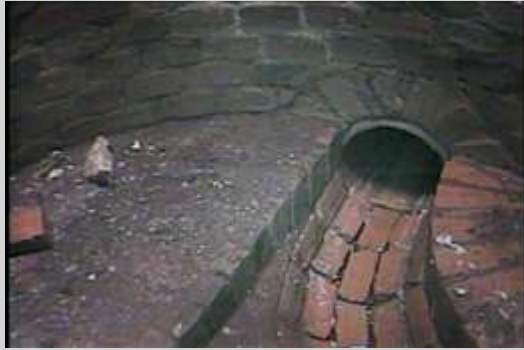
9 O'Clock Inflow

Infiltration: **None** Pipe Seal Cond: **Sound**
